**NUMBER:** 09-001-07

**GROUP:** Engine

**DATE:** March 14, 2007

Intake-to-Throttle Body Joint May Cause A Whistle-Like Sound On 3.7L Engines

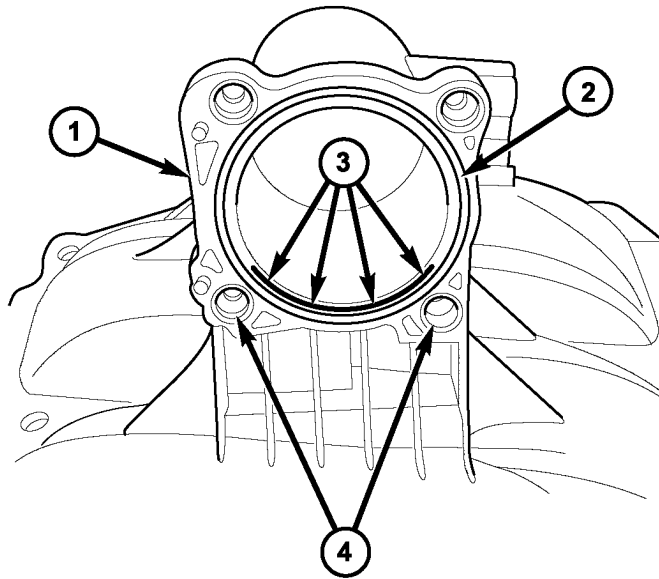
**Fig. 1 INTAKE-TO-THROTTLE BODY JOINT**

The customer may experience a slight **\*\* high frequency (pitch) \*\*** whistle-like sound while driving. This sound is not loud and may not be noticed by most drivers. The sound can occur at any ambient or engine operating temperature. The whistle-like sound is most noticeable under load, with a light throttle, and between 1,200 and 2,000 engine RPM's.

1. Disconnect and isolate the negative battery cable from the battery.
2. Remove the Electronic Throttle Control (ETC) throttle body from the intake manifold. For detailed service information refer to TechCONNECT, select the Service Info tab > 14 - Fuel System > Fuel Injection - Gas > Throttle Body > Removal or Installation > Throttle Body - 3.7L.
3. Apply a very small diameter bead (1 mm) of RTV to the intake manifold-to-throttle body joint. The RTV is to be applied to the lower section of the joint between the lower two throttle body bolt attachment holes (Fig. 1). **A very small amount of RTV is needed to seal the slight space/gap on the inner surface of the joint.** The gap was created by a slight taper in the intake manifold joint surface.

**NOTE: Do not apply an excessive amount of RTV to the joint.**

- 1 - Intake Manifold
- 2 - Intake-to-Throttle Body Gasket
- 3 - Apply Very Small Diameter Bead Of RTV Between Two Lower Bolt Holes
- 4 - Two Lower Bolt Holes

- 4. Install the ETC throttle body to the intake manifold. Tighten the throttle body four attaching bolts to 7 Nm (60 in. lbs.).

**NOTE: Wipe off inside joint of any excess RTV squeeze-out.**
