**NUMBER:** 18-018-06

**DATE:** May 13, 2006

FLASH: MIL Illumination At Start-Up Due To DTC P2112 Or P1521

This bulletin involves selectively erasing and reprogramming the Powertrain Control Module (PCM) with new software.

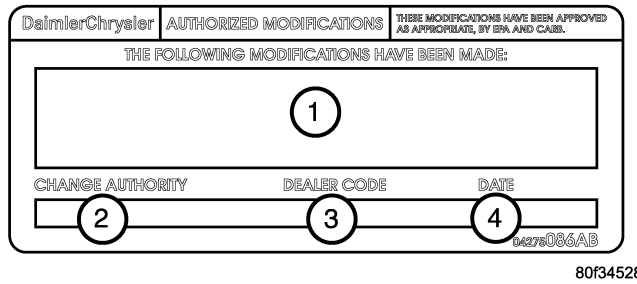
**Fig. 1 AUTHORIZED MODIFICATION LABEL**

- 1 - POWERTRAIN CONTROL MODULE P/N (INSERT P/N) USED
- 2 - CHANGE AUTHORITY: TSB XX-XXX-XX
- 3 - DEALER CODE: XXXXX
- 4 - DATE: XX-XX-XX

6. Type the necessary information on the "Authorized Modification Label" p/n 04275086AB and attach near the VECI label ([Fig. 1](#)).
