NUMBER: 23-039-07

Second Row 40/20/40 Fold & Tumble Seat Mechanism Binding

2006 - ****2007**** (XK)

Commander

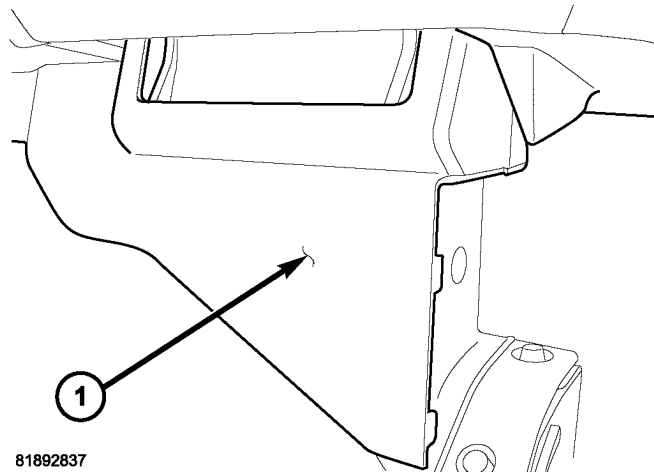
Fig. 2 FRONT TUMBLE MECHANISM SHIELD

1 - FRONT TUMBLE MECHANISM SHIELD

1. Remove the trim cover end cap (Fig. 1).
2. Remove the front tumble mechanism shield (Fig. 2).

11. Verify that the condition no longer exists by cycling the 40% seat. Attempt to tumble the seat from the fold flat position repeatedly.
12. Install the front tumble mechanism shield ([Fig. 2](#)).

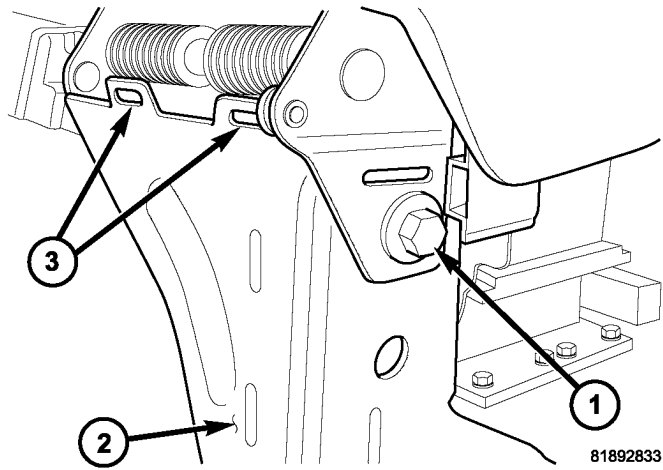
Fig. 3 OUTBOARD TUMBLE MECHANISM BOLT

- 1 - OUTBOARD TUMBLE MECHANISM BOLT
- 2 - FORWARD SEAT LEG
- 3 - NOTE TAB POSITIONS

-
3. Note the position of the two tabs (fore and aft) on the forward seat leg (Fig. 3).
 4. Make sure the seat is in the fold flat position with the latches engaged. Loosen the outboard tumble mechanism bolt (Fig. 3).

8. Have the tabs on the forward seat leg moved from their original position as illustrated in (Fig. 3)?
 - a. Yes >> go to [Step #9](#).
 - b. No >> Repeat [Step #5](#) through [Step #8](#).

9. Tighten the underside tumble mechanism bolt to 34 N·m (25 ft. lbs.) ([Fig. 4](#)).
10. Tighten the outboard tumble mechanism bolt to 34 N·m (25 ft. lbs.) ([Fig. 3](#)).

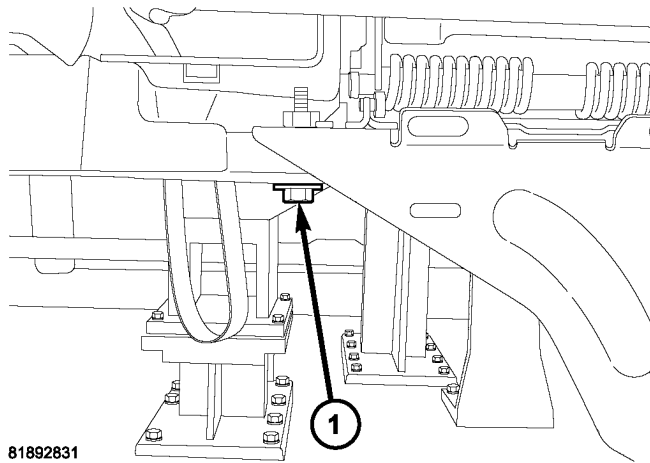
Fig. 4 UNDERSIDE TUMBLE MECHANISM BOLT

- 1 - UNDERSIDE TUMBLE MECHANISM BOLT

5. Loosen the underside tumble mechanism bolt (Fig. 4)
